Subject: Site Assessment Report
S&K Hand Tools Site
Defiance, Defiance County, Ohio
Technical Direction Document No. TO-01-11-09-0022
OTIE Contract No. EP-S5-10-10

**SITE ASSESSMENT REPORT
S&K HAND TOOLS SITE
DEFIANCE, DEFIANCE COUNTY, OHIO**

TDD No.:	TO-01-11-09-0022
Date Prepared:	January 23, 2012
Contract No.:	EP-S5-10-10
Prepared by:	OTIE
START Project Manager:	Naren Babu
Telephone No.:	(312) 220-7000
U.S. EPA On-Scene Coordinator:	Brian Kelly
Telephone No.:	(734) 692-7684

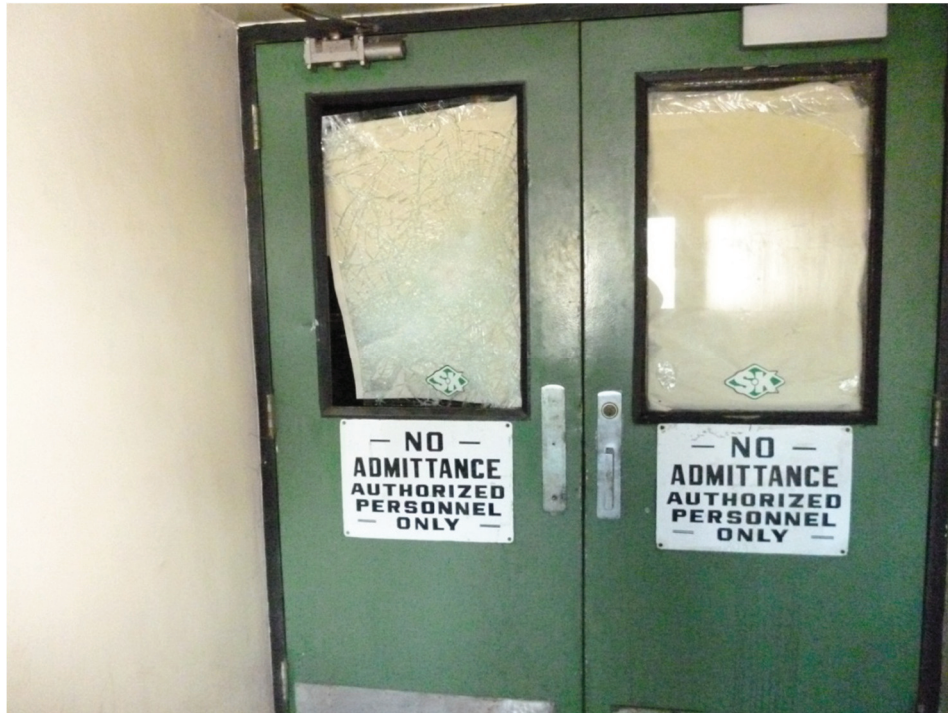
Photograph No.: 1 **Photographer:** Naren Babu **Orientation:** Northeast
TDD Number: TO-01-11-09-0022 **Contract:** EP-S5-10-10, OTIE **Date:** November 30, 2011
Site Name & Location: S&K Hand Tool Site, Defiance, Defiance County, OH
Subject: Broken window in the left side office door, providing easy access to opening the door.

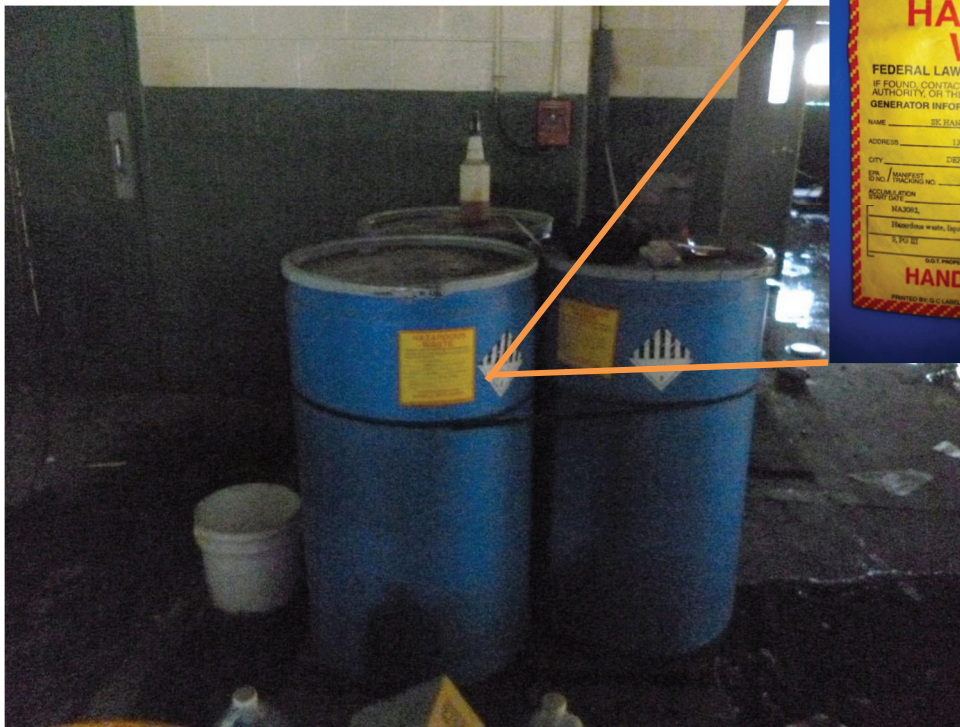
Several blue poly drums labeled with Class “9” placards were observed on the south side of the dock (Photo #3). These drums were also labeled with yellow and red hazardous waste labels with EPA Waste Numbers F006 and D007. Eighty five-55 gallon drums and two~35 gallon drums were found near the west end of the shipping areas of the facility (Photo #4). Several small containers, eleven small poly drums and 21 drums of 55-gallon capacity were observed in the east end of the shipping area. Some of the blue poly 55-gallon drums had labels of “MURIATIC ACID 22° BE”, “HYDROCHLORIC ACID 20 BE”, “SODIUM BISULFATE LIQUID 40%”, and “SULFURIC ACID 66°BE” all accompanied by “corrosive” labels (Photo #5). The “BE” in the label refers to baume, which is a measure of the specific gravity of a liquid. A 55-gallon drum labeled with a “water soluble degreasing solvent” manufactured by “CHEMSEARCH” was located in the plating facility (Photo #6). Two 3,000 gallon tanks with unknown contents were observed outside of the building at the south end of the plating room.

Several blue poly drums labeled with Class “9” placards were observed on the south side of the dock (Photo #3). These drums were also labeled with yellow and red hazardous waste labels with EPA Waste Numbers F006 and D007. EPA hazardous waste number F006 indicates the drums contain wastewater treatment sludges from electroplating per the 40 CFR 261.31 regulations for hazardous waste from non-specific sources. EPA hazardous waste number D007 indicates that the contents of the drums exceed the maximum concentration of contaminants for the toxicity characteristic of 5.0 mg/L for chromium per 40 CFR 261.24.

Photograph No.: 3 **Photographer:** Naren Babu **Orientation:** East
TDD Number: TO-01-11-09-0022 **Contract:** EP-S5-10-10, OTIE **Date:** November 30, 2011
Site Name & Location: S&K Hand Tool Site, Defiance, Defiance County, OH
Subject: Blue poly drum on south side of dock with Hazardous Waste class '9' placards.

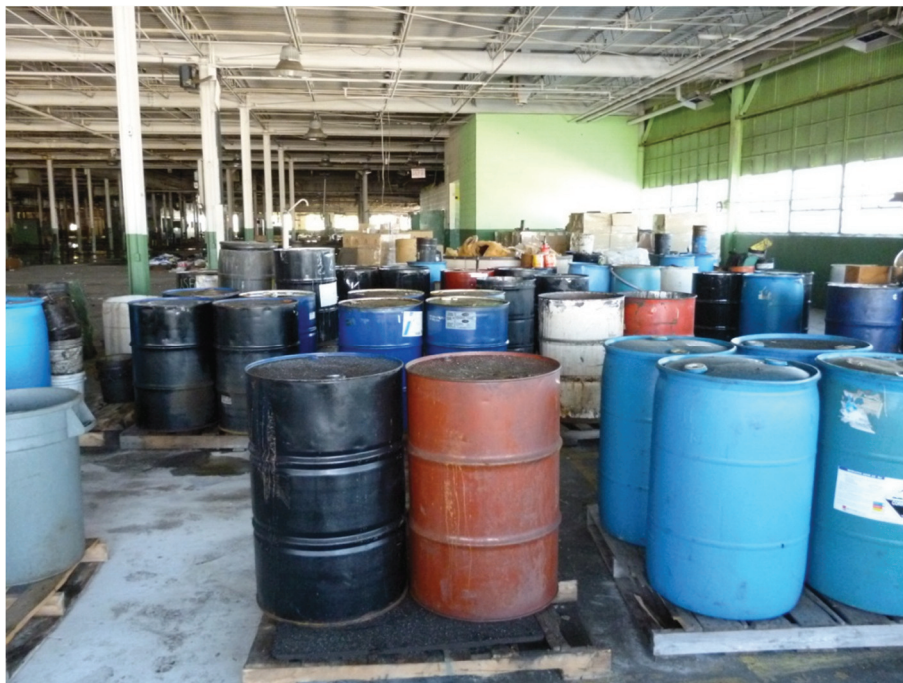
Photograph No.: 4 **Photographer:** Naren Babu **Orientation:** West
TDD Number: TO-01-11-09-0022 **Contract:** EP-S5-10-10, OTIE **Date:** November 30, 2011
Site Name & Location: S&K Hand Tool Site, Defiance, Defiance County, OH
Subject: Drums in the west end of the shipping area.

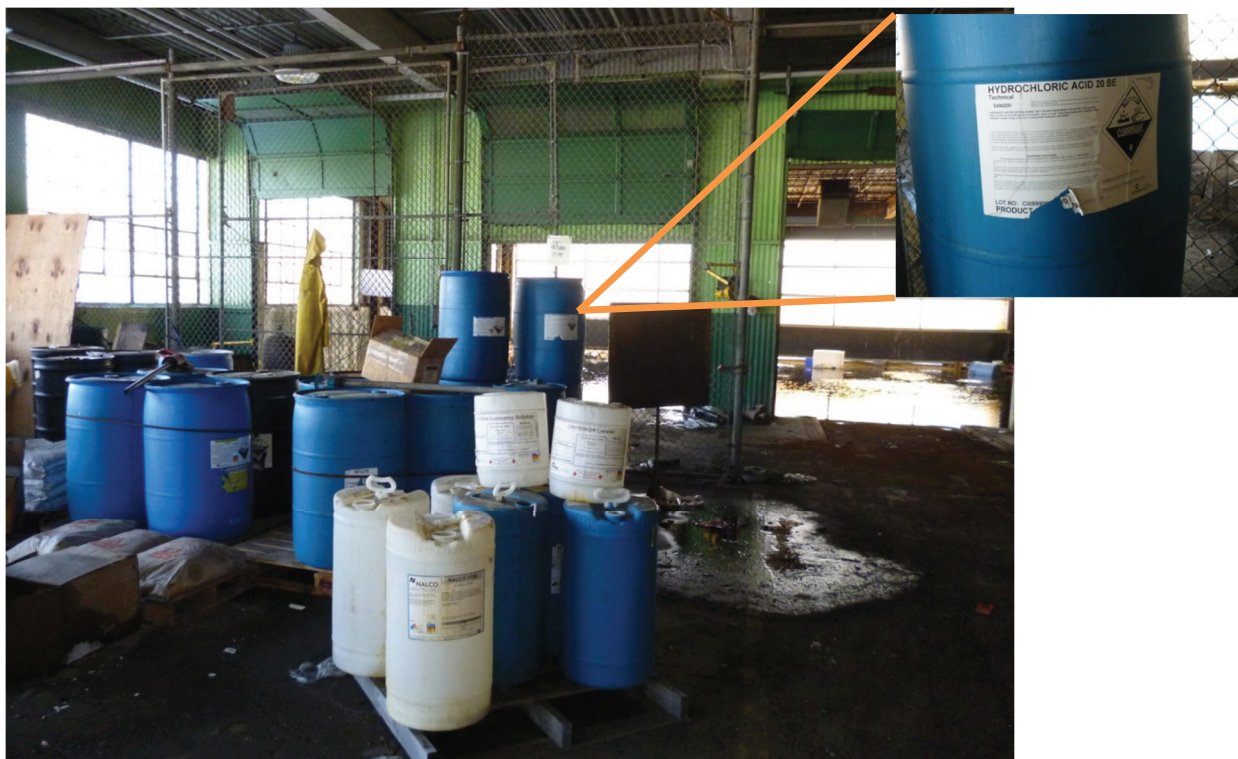
Photograph No.:	5	Photographer:	Naren Babu	Orientation:	East
TDD Number:	TO-01-11-09-0022	Contract:	EP-S5-10-10, OTIE	Date:	November 30, 2011
Site Name & Location:	S&K Hand Tool Site, Defiance, Defiance County, OH				
Subject:	Acid drums located at the east end of the shipping area.

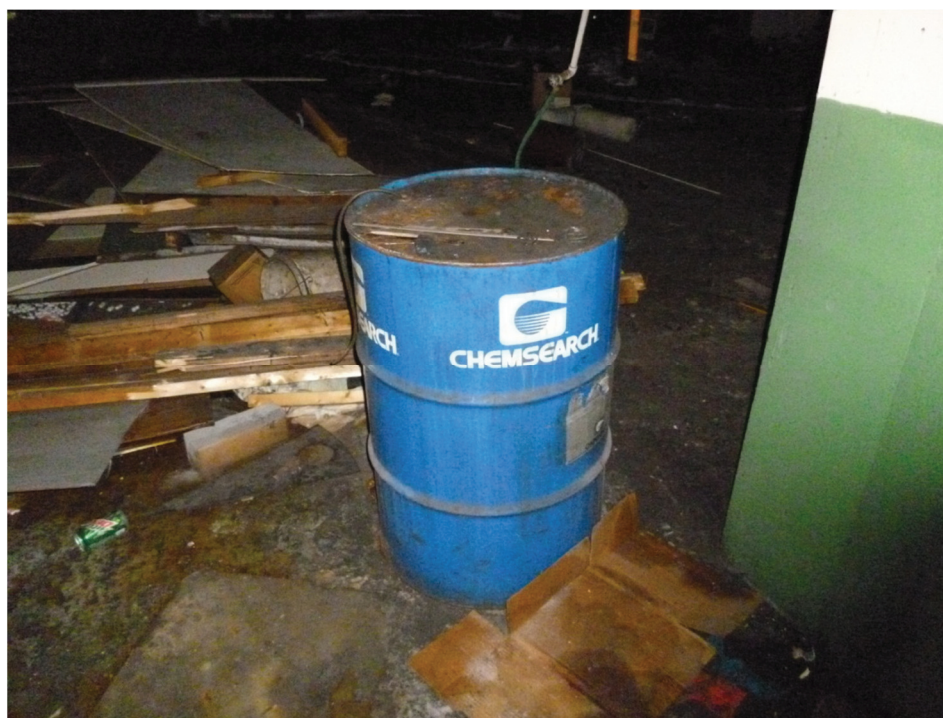
Photograph No.:	6	Photographer:	Naren Babu	Orientation:	Looking down
TDD Number:	TO-01-11-09-0022	Contract:	EP-S5-10-10, OTIE	Date:	November 30, 2011
Site Name & Location:	S&K Hand Tool Site, Defiance, Defiance County, OH				
Subject:	Metal drum with "water soluble degreasing solvent" label and manufactured by "CHEMSEARCH"

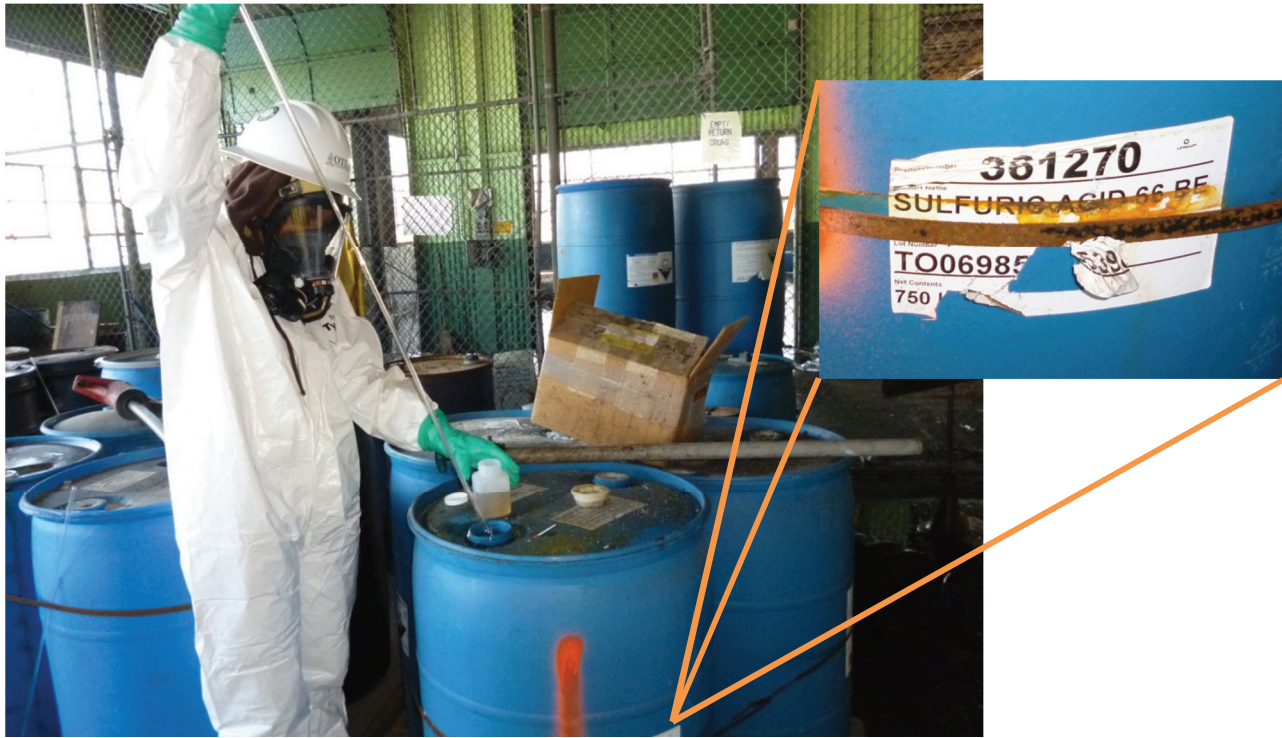
Analytical results of liquid drum samples SK-DRUM-001 and SK-DRUM-002 indicated a pH of 2 standard units (SU). The Hazardous Characterization criteria for corrosivity per 40 CFR Section 261.22 regulations is a pH of less than or equal to 2 SU (≤ 2) or greater than or equal to 12.5 SU (≥ 12.5). Based on the analytical results, of sample SK-DRUM-001 and SK-DRUM-002, their respective drum contents are classified as corrosive liquids.

The sample results of SK-DRUM-001 and SK-DRUM-002 indicate that the blue poly drums contain strong acids that satisfy the Hazardous Characterization criteria for corrosivity per 40 CFR Section 261.22.

Photograph No.: 7 **Photographer:** Naren Babu **Orientation:** East
TDD Number: TO-01-11-09-0022 **Contract:** EP-S5-10-10, OTIE **Date:** November 30, 2011
Site Name & Location: S&K Hand Tool Site, Defiance, Defiance County, OH
Subject: START collecting sample SK-DRUM-001 from a blue poly drum labeled "sulfuric acid" in the east end of the shipping area. Analytical results indicated a pH of 2 SU.
